# OBSERVATIONS FOLLOWING A HEAVY RAINFALL ON THE RIMUTAKA RANGE

A. Cunningham and W. B. Arnott\*

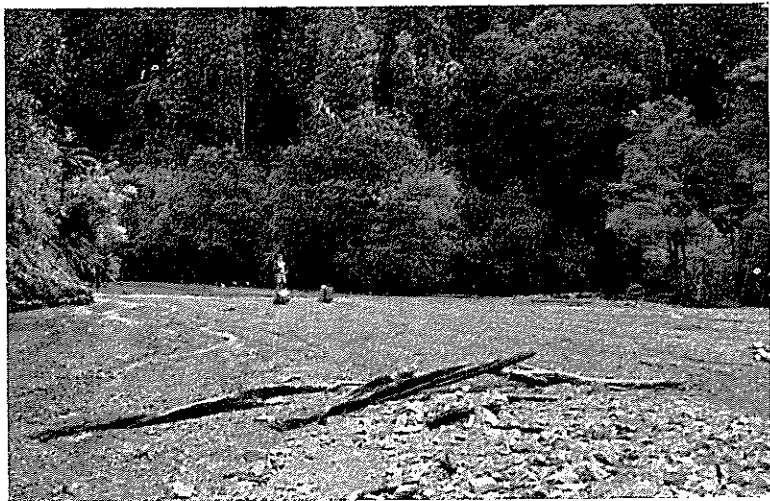
On 10 January we travelled up the valley of the Wairongomai. This river was swollen and very discoloured, and much recent flood debris was seen along its banks. At the point where a large unnamed tributary enters the Wairongomai from the west (grid ref. 636259 on Fig. 3) we found that the discoloured water was entering from the western tributary, and that the main stream contained clear water. A few hundred yards up the western tributary the stream forks again (grid ref. 631258). At this point the branch from the NW was noted to be quite clear and appeared to have suffered no recent flood damage. The branch from the south, however, was very dirty, and was in the process of flowing in ever-changing courses over a large fan of recently deposited sand and stone particles (Fig. 4).

Fig. 4 — ALLUVIAL FAN being built up by the southern tributary of the Wairongomai, which has a catchment area of 380 acres. The NW tributary (770 acres), which is not contributing to the detritus, enters at the right of the photo.

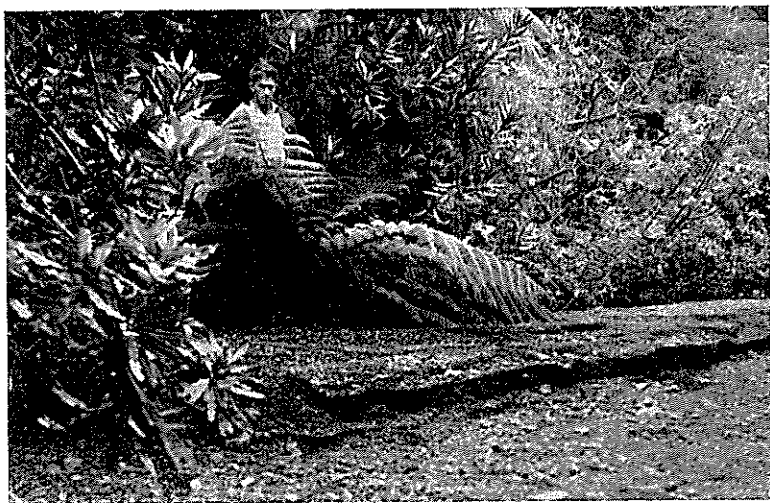
FIG. 5 — RECENTLY DEPOSITED SHINGLE partly burying plants along the banks of the southern tributary of the Wairongomai. Goats, which are common in this area, had not yet heavily browsed these plants, many of which are palatable to them. The crown of a tree fern with foliage of this size would be at least 6ft above the ground.

We travelled up this southern tributary, the lower section of which, to judge from half buried trees, ferns, and other plants along the bank, appeared to have been recently aggraded by several feet (Fig. 5).
