## IMPACT OF URBANIZATION ON THE HYDROLOGY OF WAIRAU CREEK, NORTH SHORE, AUCKLAND

### ABSTRACT

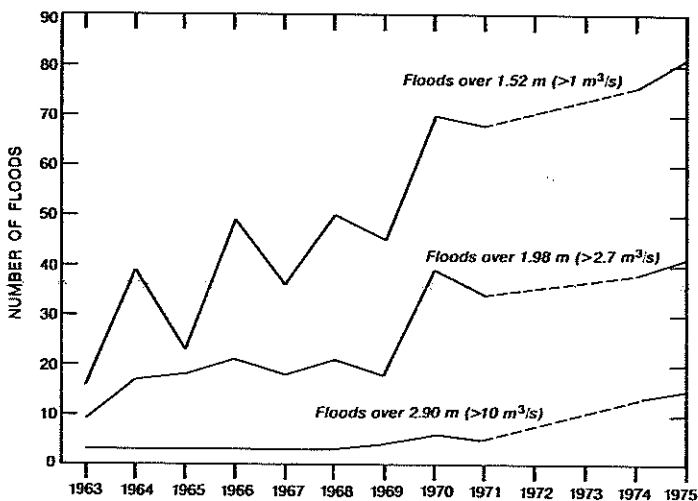
FIG. 4 — Wairau Creek: number of floods.

An investigation of flooding frequency was stimulated because of many local complaints that the incidence of flooding had markedly increased. In order first to establish if the increased flooding was real or perceived, the numbers of floods per annum exceeding three heights were noted and plotted for each year of record (Fig. 4). The three heights were selected to include bankfull and two arbitrary lower levels as follows: (1) bankfull (2.90 m old channel stage, approximately  $10 \text{ m}^3/\text{s}$  discharge), (2) 1.98 m old channel stage ( $2.7 \text{ m}^3/\text{s}$ ) and (3) 1.52 m (just over  $1 \text{ m}^3/\text{s}$ ). For comparison, mean annual discharge is approximately  $0.21 \text{ m}^3/\text{s}$ , which was represented by an old channel stage of 1.01 m.

The conclusions that may be drawn from this simple analysis are (1) that flooding frequency undoubtedly increased during the period, although overbank flooding only increased after 1968 (by which time 53 percent of the basin was urbanized), and (2) that there is an inverse relationship between flood frequency increase and flood magnitude. The number of small ( $> 1 \text{ m}^3/\text{s}$ ) floods contained within the channel increased five times, whereas larger floods were until recently progressively less influenced. Since 1972, how-

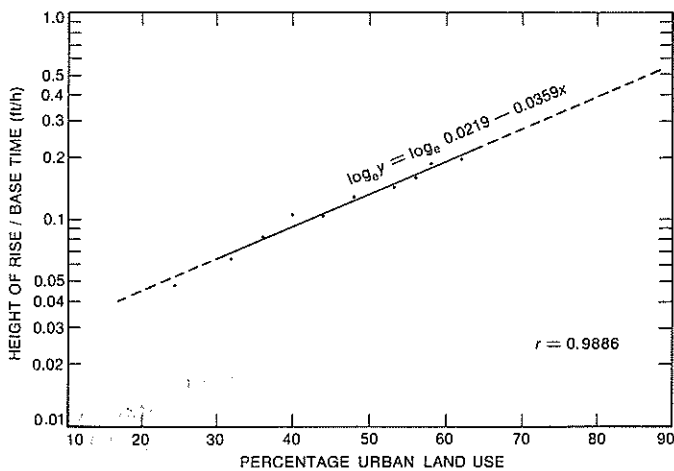
FIG. 8 — Wairau Creek: flood peakedness.

Detailed examination of flood hydrographs (Fig. 6) reveals further changes to have occurred. The mean height of rise of floods was found to increase directly with the percentage of urban land use (Fig. 7). Simultaneously, the mean time of rise of these floods decreased steadily from about 7 hours in 1963 to 5.5 hours in 1971. The floods also ran off more rapidly, the mean duration of a flood (the base time) more than halving from 70.6 hours in 1963 to 32.7 hours in 1971. Thus the general effect of urbanization has been for floods to strike more swiftly, rise higher and to run off more rapidly than before. Floods are thus more peaked (Fig. 8), with the

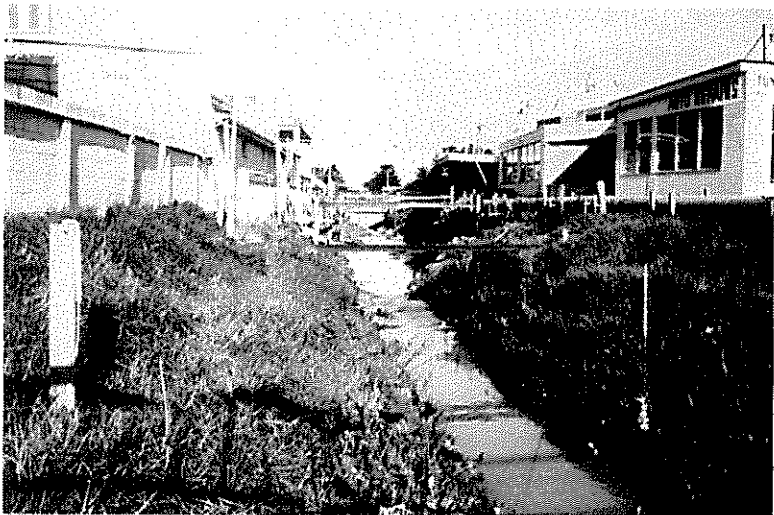
FIG. 12 — Wairau Creek in the Wairau Road industrial and commercial estate, showing the original stream channel and building development to the edge of the floodplain.

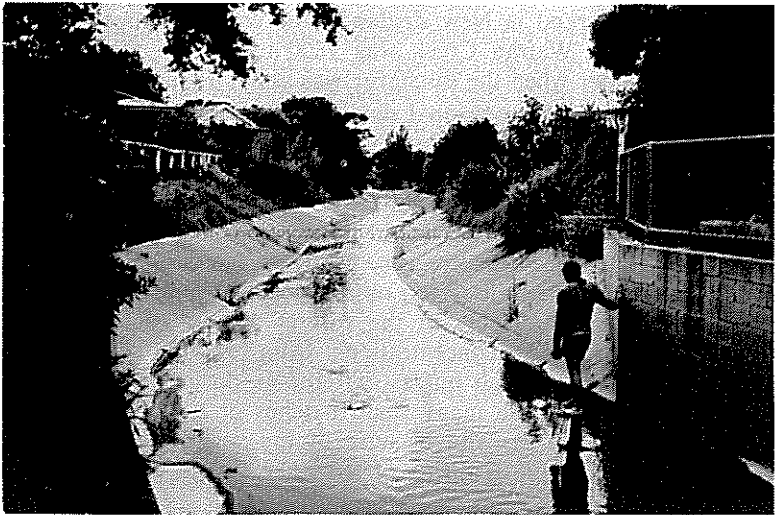
FIG 13—The enlarged and concrete-lined channel of the Wairau Creek immediately downstream of the Alma Road gauging site.

Overbank flooding in the Wairau Creek before major channel improvements commenced occurred four to six times annually instead of perhaps twice every three years under natural conditions. These floods resulted in damage to property and in loss of industrial production, which by 1974 amounted to at least \$132,000. An irate business community, having been permitted to build on a naturally flood-prone, previously swampy floodplain (Fig. 12), eventually persuaded the local authorities to initiate a flood-alleviation scheme. By 1976, this project will have cost the local community approximately \$1,500,000, and pressure is mounting for still further work. Even more serious was the drowning of a youth in the flood of June 1975 (Figs. 13 and 14).

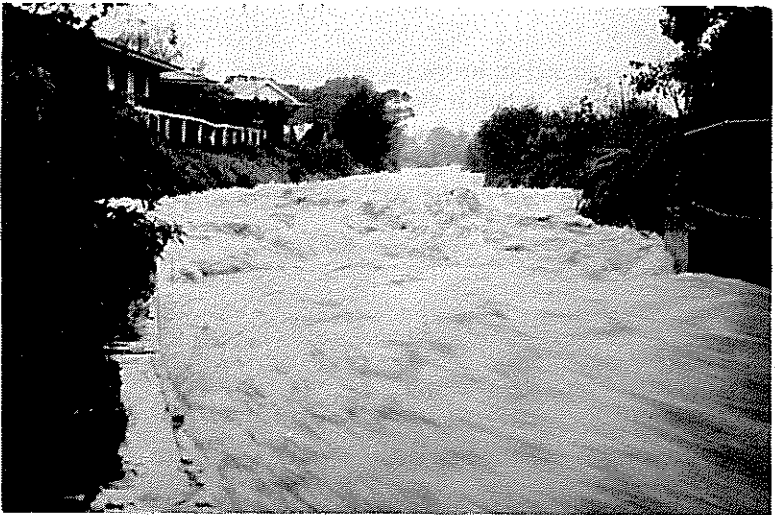
FIG. 14—The Wairau Creek at the site shown in Fig. 13 in flood in June 1975 (discharge approximately  $40\text{--}50\text{ m}^3/\text{s}$ ).
