STREAM CHANNEL MEASUREMENTS IN NEW ZEALAND (NOTE)

R. J. Eyles*

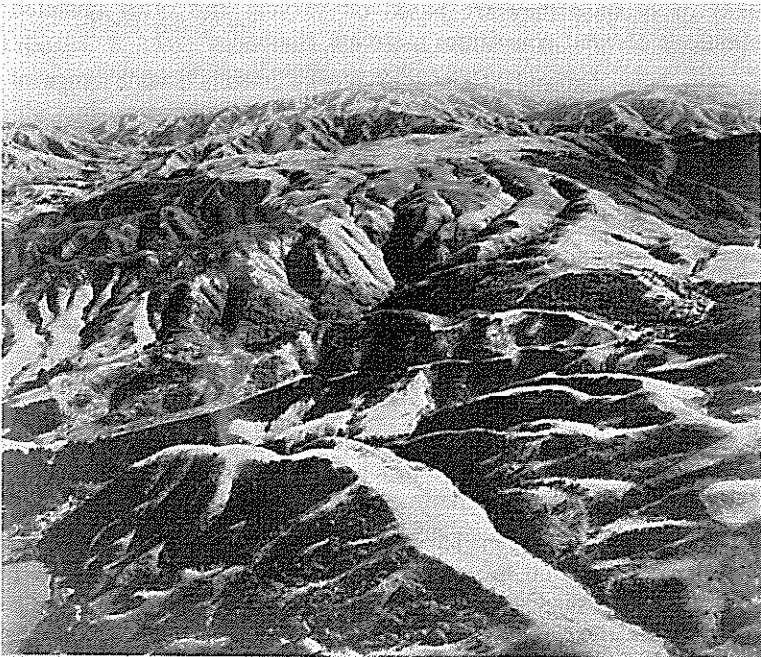
FIG. 1 — The erosion surface remnant on Quartz Hill at about 300 m above sea level as viewed from the north. Morphometric data from the very subdued summit relief clearly are not representative of the general landscape.

This is illustrated in Table 1, which contains data from the Makara Experimental Basin complex situated on Quartz Hill 8 km west of Wellington City. Quartz Hill is an uplifted remnant of an old erosion surface (Fig. 1) termed the K surface by Cotton (1957). Catchments 1 to 8 on the hill summit have "an easy rolling topography, with well grassed valley floors with no defined channels"
